BLAUPUNKT Frankfurt V7-5- (1964/65) Ampli

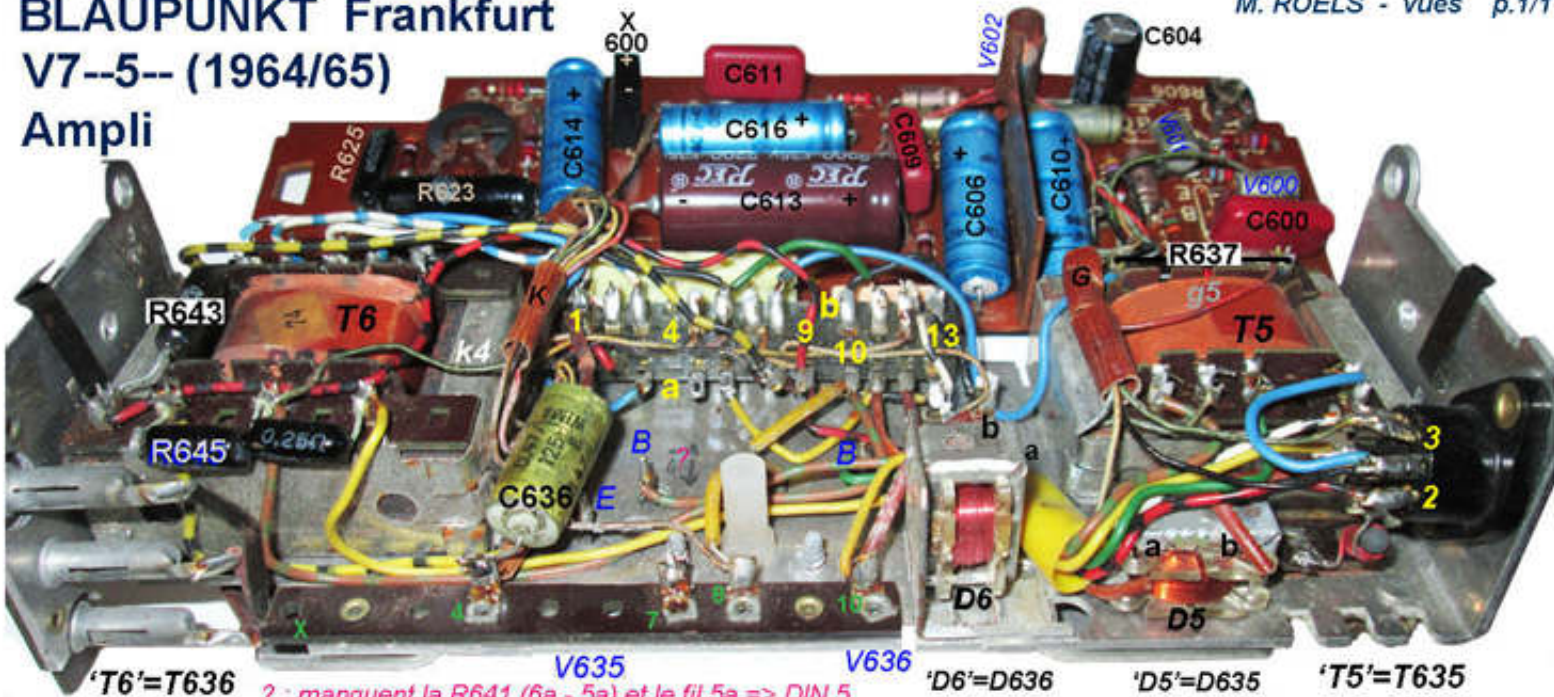
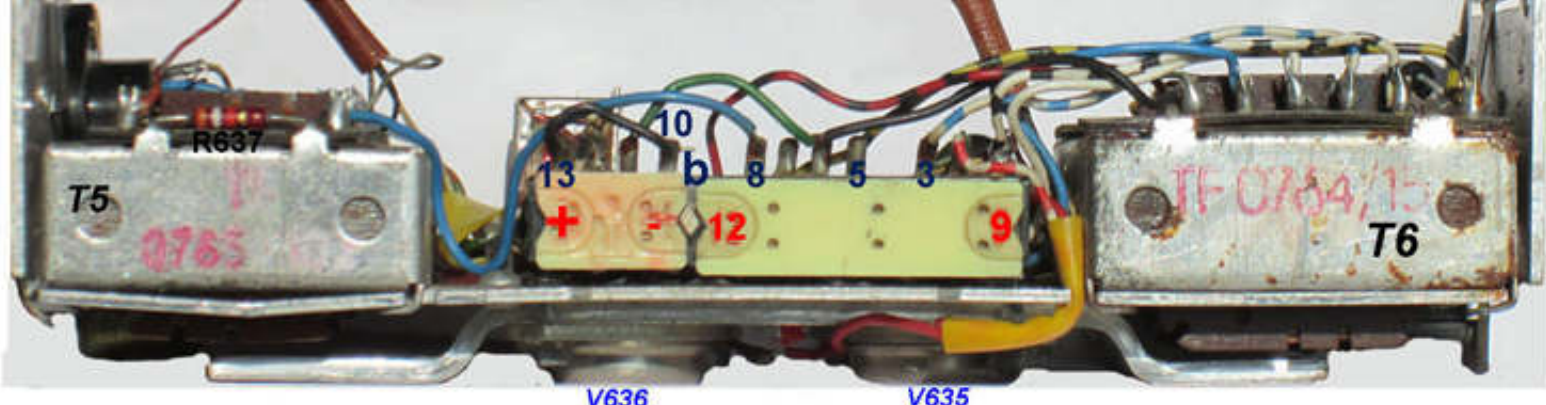
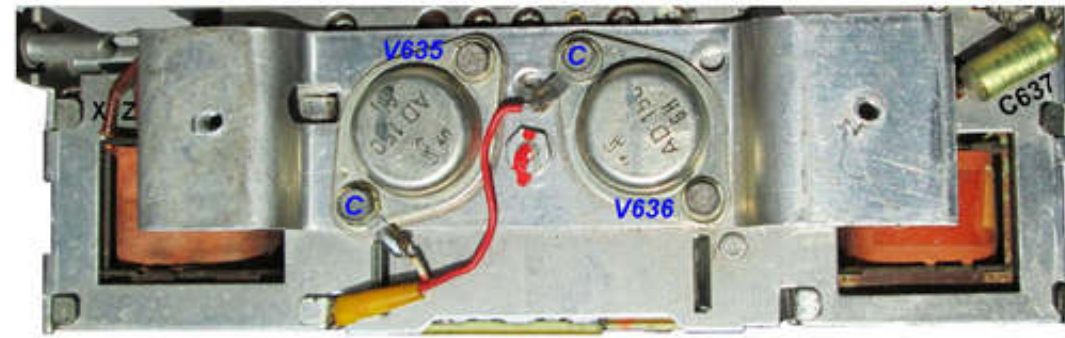
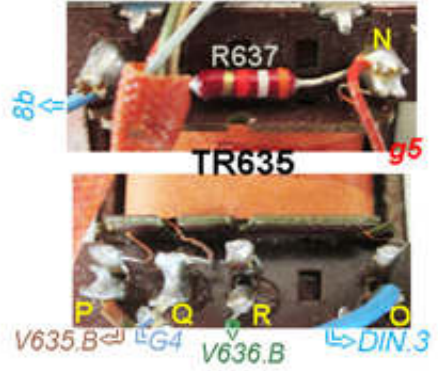
'T6'=T636 ? : manquent la R641 (6a - 5a) et le fil 5a => DIN.5 'D6'=D636 'D5'=D635 'T5'=T635

- C616+ = K1 (J) => 12b => (Bc/N) DIN.6
- C616- = K2 (N) => 8a => (J/N) R643 => (R/N) 9a => (R/N) DIN.2
- C613- = K3 (R) => 6b { => (V) 11b
- R626 = K3 (R) => 6b { => (N) T6.U
- R620 = K4 (V) => { R645 T5.- => (MV) 10a => (J) R635
- R644
- R620 = K5 (M) => X8 => (J) R635
- R621
- R623
- R625 = K6 (Be) => 5b
- R626

- C600 = G1 (V) => DIN.4
- C603- = G2 (N) => DIN.3 => (Bl) T5.O
- R609 = G3 (Be) => 7b
- V601.C
- R621 = G4 (Bl) => T5.Q
- C609 = G5 (5R) { => T1.N
- C612+ { => R637

N.B.: Sur cet ampli, R636 ne figure pas
et C636 est branché entre 1a et 1b
